FIRE HAZARD

ON HEMTT -A4

MODELS.

PS 691 13 JUN 10

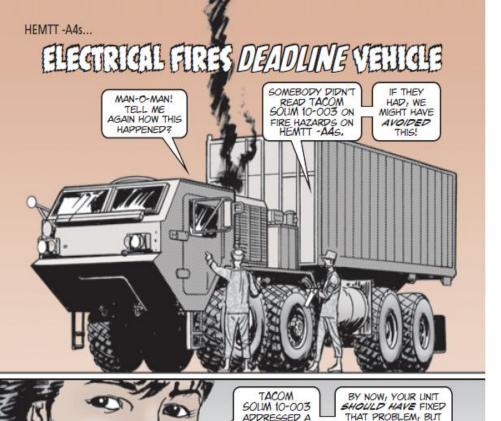
Unit commanders should deadline all HEMTT -A4 models that haven't had a hydraulic line inspection and corrective repair performed yet! Park these HEMTTs and set the 24V battery disconnect switch to OFF. Otherwise, a problem with electrical fires could destroy the HEMTT -A4 or kill or hurt Soldiers.

Hydraulic lines rubbing on the positive starter terminal is the root cause of these fires. The outer layer of the hose eventually wears through to the metal reinforcements. That leads to arcing between the starter terminal and the hydraulic line, which sets leaking hydraulic fluid on fire.

1) Emergency fix: This option is only approved for Afghanistan. Just use hose ties to isolate the hydraulic hoses from the starter terminal. Then do the interim fix as soon as possible.

2) Interim fix: For this option, worn hoses shall be replaced before applying the interim fix to the vehicles. A standoff bracket and hose-restraining straps attach the hydraulic lines to the charge air cooler posts. This keeps the lines away from the starter terminals and other electrical connections. Use this method until the permanent fix can be applied.

3) Permanent fix: As parts become available, the contractor will apply this permanent solution for your unit's HEMTT -A4 fleet. They'll lock the hydraulic and electrical routings into a single configuration using pillow blocks and P-clamps to secure the hoses.
